US Forest Service Aviation Safety Alert

No. FS 09-02

July 31, 2009

Subject: Rappel Equipment and Procedural Change
Area of Concern: Rappel Operations
Distribution: Rappel Bases

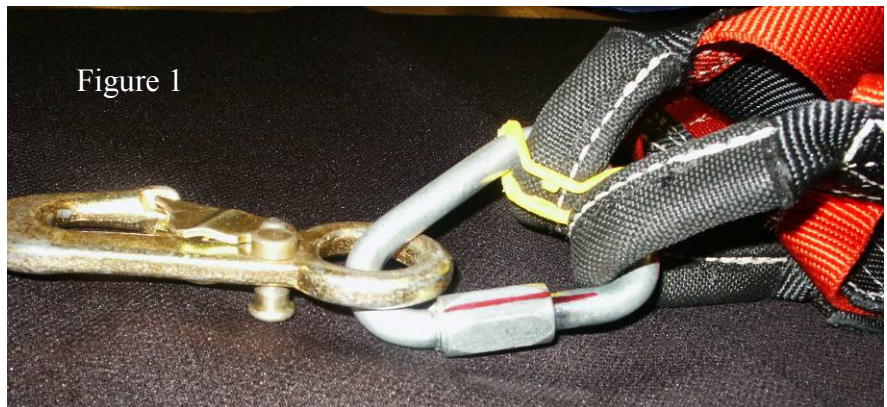
Required Action: All rappel bases shall **immediately discontinue** the practice of opening the Maillon Rapide tri-link on the HR-2 rappel harness for any purpose other than (1) changing a defective Forgecraft or Bourdon snap hook or (2) replacing the rubber O-ring/Kong Clip that secures the right soft loop to the right corner of the tri-link.

When it becomes necessary to change a snap hook or O-ring/Kong Clip, the work shall be performed by a qualified rappel spotter. After replacing the defective part, the locking nut on the tri-link shall be tightened with a wrench until it is not possible to unscrew the locking nut by hand (using fingers only, no wrench).

After the locking nut is tightened, a contrasting color of fingernail polish shall be used to apply a longitudinal witness mark on the uppermost facet of the locking nut extending $\frac{1}{2}$ inch onto the tri-link (red line on tri-link in Figure 1). The witness mark will permit a rappeller or rappel spotter to confirm through visual inspection that the locking nut is secure and has not rotated since it was tightened.

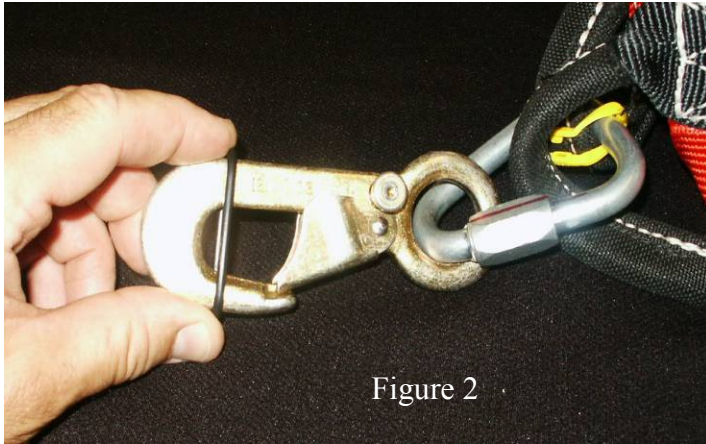
Figure 2

In addition, **discontinue immediately** the practice of using Kong Clips to keep the rappel locking snap hook eye located at the apex of the Maillon Rapide tri-link (this order applies to both Forgecraft and Bourdon snap hooks). The only approved accessory for positioning the snap hook at the tri-link apex shall be a 1 1/16" diameter rubber O-ring.

To install an apex O-ring, slip the O-ring over the tip of the snap hook (Figure 2), and slide the O-ring down the snap hook (Figure 3) and over the eye until the O-ring contacts the tri-link (Figures 4,5). Any qualified rappeller can replace a snap hook O-ring as long as they do not open the tri-link during the process.
